FIRE SAFETY CONDITIONS AT HISTORIC BUILDINGS: CATHEDRAL OF PORTO CASE

Ana Castro¹, Miguel Chichorro Gonçalves², Gonçalo Perestrelo³

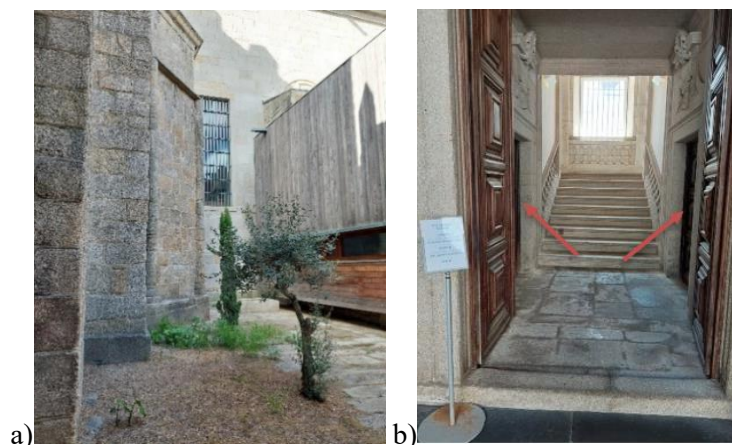
Figure 3. a) The confrontation between the stone facade and the wooden façade; b) Wooden doors accessing the Nasoni staircase

The area of the building where the spaces allocated to technical and administrative services are located is a more recent construction, with wooden facades, compared to the oldest part of the building (Figure 3a), so the openings in the oldest construction must be protected appropriately and ensure compartmentalization to prevent the spread of fire. On the Nasoni staircase, it is essential to reinforce the wooden side doors at the beginning of the staircase (Figure 3b) and along it to guarantee the protection of this vertical escape route from the adjacent spaces (two chapels), whose accesses can also take this ladder. On the staircase leading to the North Tower, consideration should be given to the possibility of placing a second door on the landing located at the level of the upper cloister (Figure 4) to isolate the staircase on the way down, preventing the smoke spreading to the organ area and the top of the tower, hindering its evacuation. In this way, the compartmentalization of the two areas delimited in red and brown in Figure 1 is simultaneously guaranteed.
